### Jim Barrett - Re: Fwd: 5700 Block of Soledad Mt. Road - Concerns of Citizens

Re: Fwd: 5700 Block of Soledad Mt. Road - Concerns of Citizens

Hossein, Jim, & Patti: I visited the site this morning. After examining the repair and the pavement crack, as well as surrounding improvments, I concluded that there was no discernable evidence for a major landslide. It is still possible that some large-scale movement has taken place, but I would expect to see more movement reflected in the street, curb, gutter and sidewalk, as well as utility lines. Except for the asphalt patch and tear in the paving, the street only exhibited only typical minor cracking in the pavement which was likely from shrinkage. No evidence of movement was observed in the curb, gutter & sidewalk.

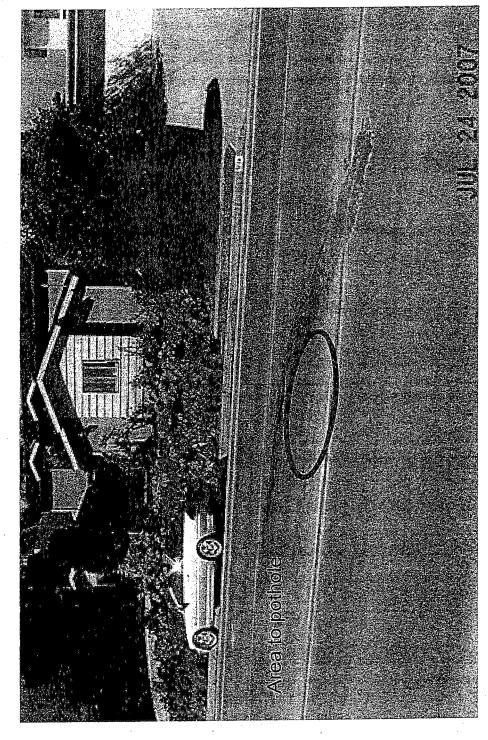
7500 Block Soledad Mountain

Minor pavement cracking

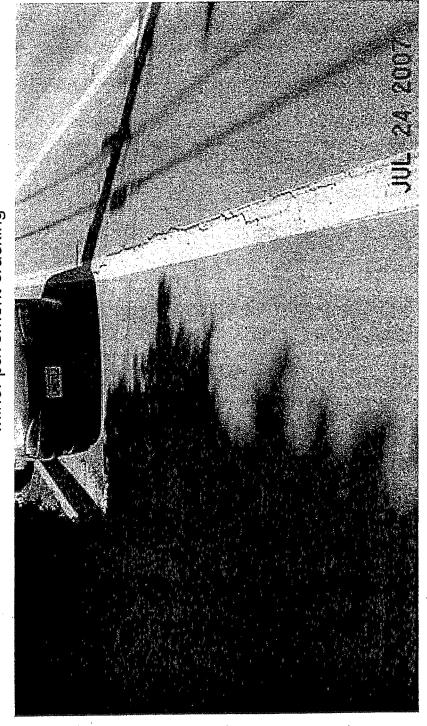
No discernable evidence for large scale gross movement (landslide), or movement ment of public and private improvements
